# No. 1441936.0

SAMPLE DESCRIPTION:  
Flooring Planks – Knight Tile range 2.0mm plank samples fixed to clear Perspex base using:  
- 888 Cementitious Feather finish and absorbent mat used to prepare Perspex to receive planks.  
- Karndean Megabond hard set adhesive.

## ISO 4760:2022(E) - LAMINATE FLOORING – TOPICAL MOISTURE RESISTANCE – ASSEMBLED JOINT (MODIFIED)

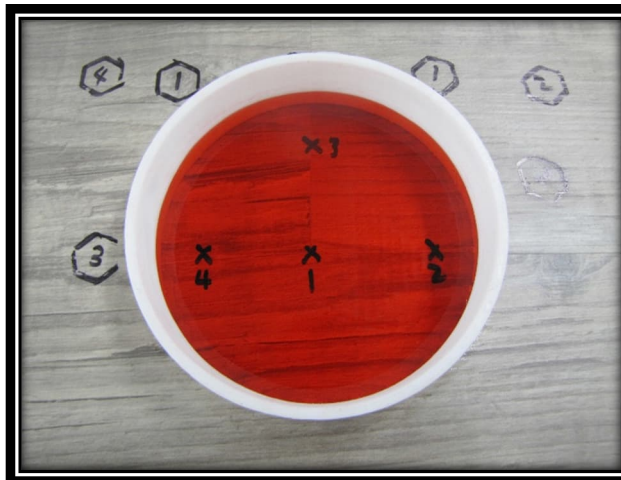
24 hrs With Water

100 mls of dye solution was applied onto the sample surface. It was poured into a cylinder 100mm diameter placed in the centre of the sample at the “T joint.” Sealant was used at the plank/cylinder interface to avoid leakage.

The underside of the sample was inspected through the clear Perspex to enable detection of any dye penetration through the sample.
