# No. 1441939.4

SAMPLE DESCRIPTION:  
Flooring Planks: Van Gogh range 3.0mm plank  
samples fixed to clear Perspex base using Karndean  
2-part PU adhesive.

## ISO 4760:2022(E) - LAMINATE FLOORING – TOPICAL MOISTURE RESISTANCE – ASSEMBLED JOINT (MODIFIED)

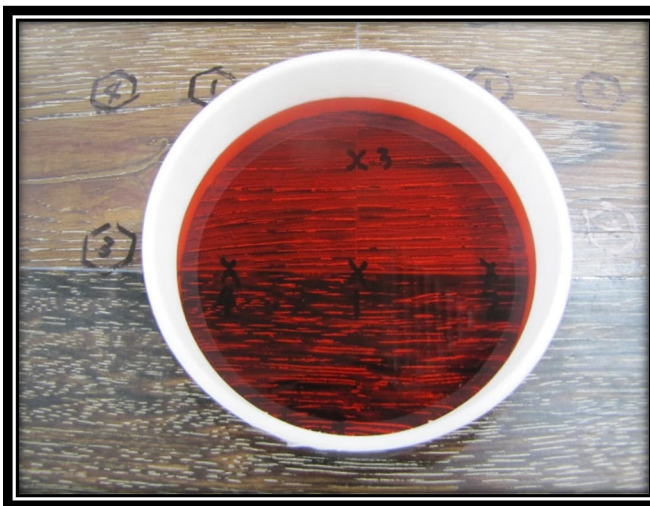
24 hrs With Water

100 mls of dye solution was applied onto the sample surface. It was poured into a cylinder 100mm diameter placed in the centre of the sample at the "T joint." Sealant was used at the plank/cylinder interface to avoid leakage.

The underside of the sample was inspected through the clear Perspex to enable detection of any dye penetration through the sample.

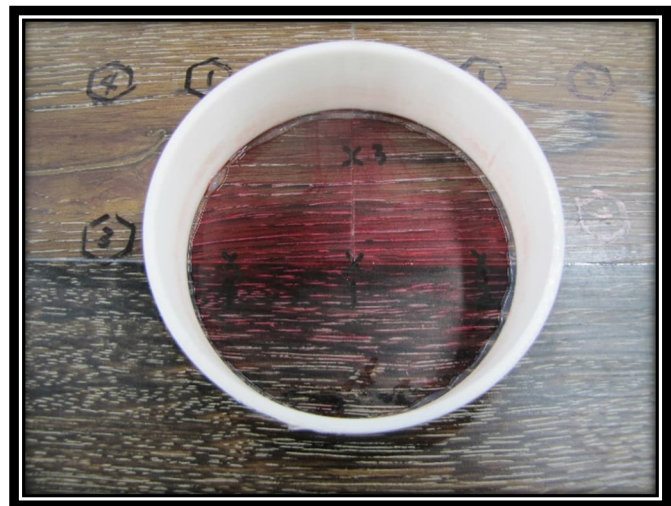
Wet Swell

Observations:	Specimen 1	Specimen 2	Specimen 3
Migration of water along the upper surface:	No	No	No
Migration of water to the underside:	No	No	No

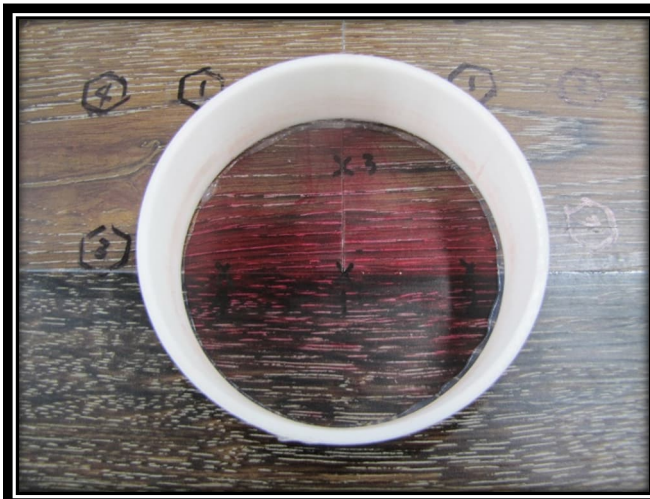
Recovered Swell

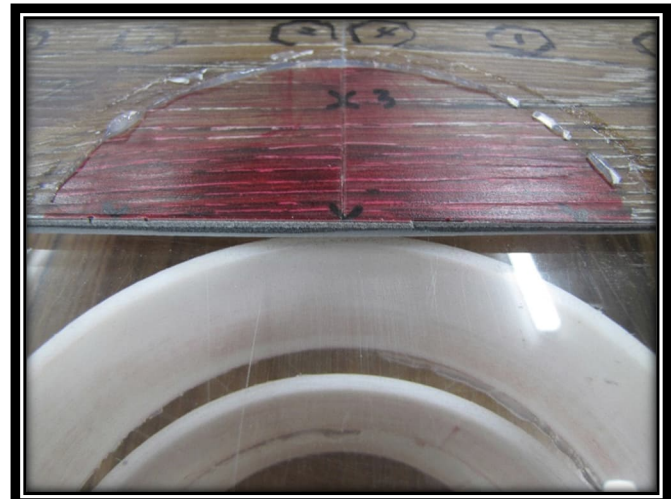
Recovered Swell (Disassembled)

Disassembly Observations:	Specimen 1	Specimen 2	Specimen 3
Migration of water along the upper surface:	No	No	No
Migration of water to the underside:	No	No	No
