No. 1446141.2

SAMPLE DESCRIPTION:
LVT Virtue range flooring plank samples fixed to a clear Perspex base using:
- Uzin 888 Cementitious feather finish and absorbent mat used to prepare Perspex to receive plank.
- KE 66 wet-set dispersion-based (hard set).

ISO 4760:2022(E) - LAMINATE FLOORING – TOPICAL MOISTURE RESISTANCE – ASSEMBLED JOINT (MODIFIED)

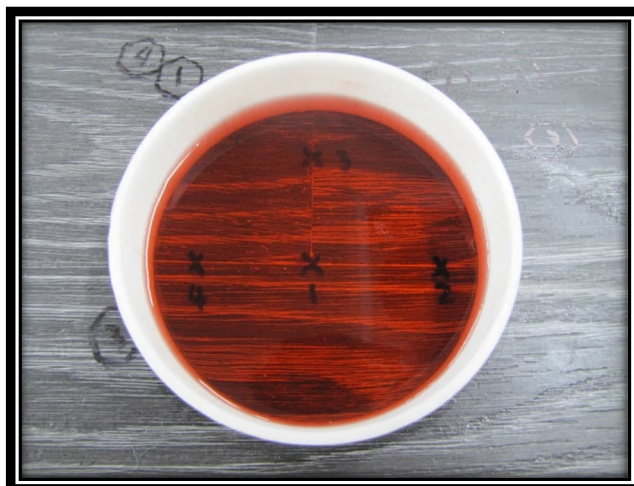
24 Hrs with Water

100 mls of dye solution was applied onto the sample surface. It was poured into a cylinder 100mm diameter placed in the centre of the sample at the "T joint." Sealant was used at the plank/cylinder interface to avoid leakage.

The underside of the sample was inspected through the clear Perspex to enable detection of any dye penetration through the sample.

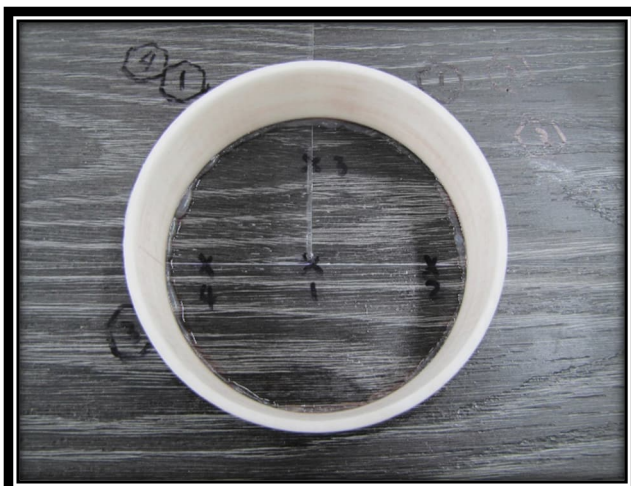
Wet Swell

Wet Swell			Recovered Swell		
	Specimen 1	Specimen 2	Specimen 3	Specimen 1	Specimen 2	Specimen 3
Qualitative Ratings (individual results):	1	1	1	1	1	1

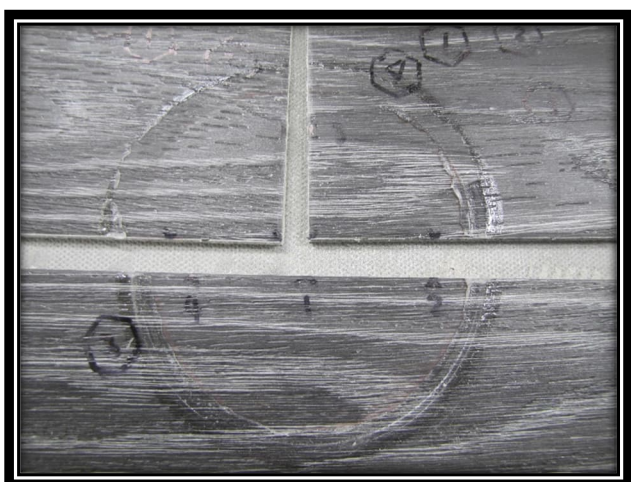
Recovered Swell (Disassembled)

Disassembly Observations:	Specimen 1	Specimen 2	Specimen 3
Migration of water along the upper surface:	No	No	No
Migration of water to the underside:	No	No	No
