No. 1428489.7

SAMPLE DESCRIPTION:
Laminate Flooring – Solido Elite WR
Nominal Size – 192mm x 1285mm
Nominal Wearlayer Thickness – 0.1mm
Locking System – Megaloc Aqua Protect

ISO 4760:2022(E) - LAMINATE FLOORING – TOPICAL MOISTURE RESISTANCE – ASSEMBLED JOINT (MODIFIED)

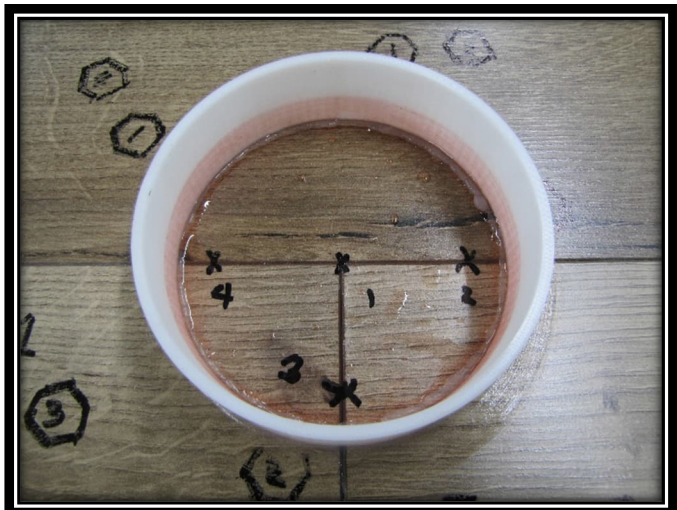
Wet Swell

| | Wet Swell | | |
|---|---|--|--|
| Observations: | No penetration through the joints. | No water penetration through the joints. | No water penetration through the joints. |
