# No. 1440935.3

SAMPLE DESCRIPTION:  
Flooring Planks – SPC Aspen Stone Plastic Composite Vinyl.

## ISO 4760:2022(E) - LAMINATE FLOORING – TOPICAL MOISTURE RESISTANCE – ASSEMBLED JOINT (MODIFIED)

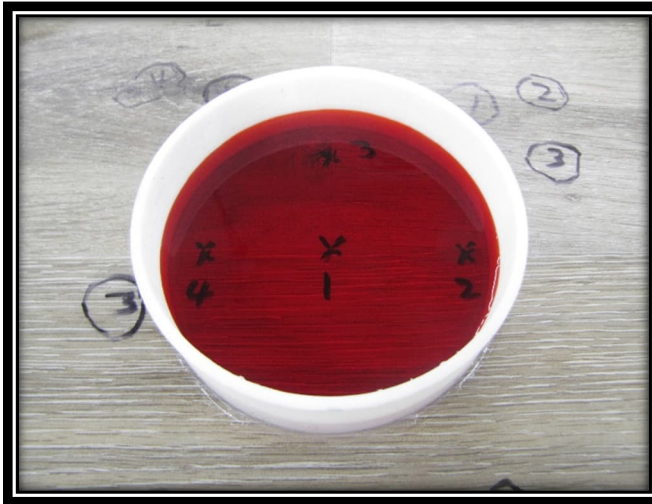
**24 hrs With Water**

Weights were placed on the outer corners of the test specimens to keep the samples flat throughout the test procedure. 100 mls of dye solution was applied onto the sample surface. It was poured into a cylinder 100mm diameter placed in the centre of the sample at the "T joint." Sealant was used at the plank/cylinder interface to avoid leakage.

The sample was left at 20°C, 65% Relative Humidity room conditions for 24 hours after the dye was added and then examined for dye penetration through the backing (not 23°C, 50% RH as stated in the method).

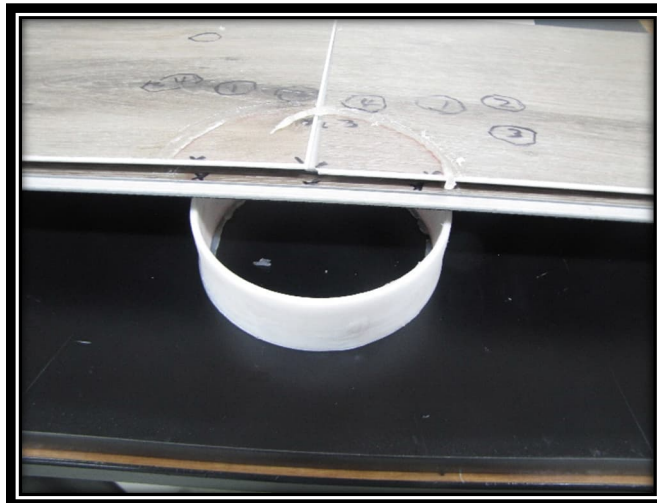
**Recovered Swell (Disassembled)**

- 1 = No change - Little to no noticeable change in edge swell or panel surface lift
- 2 = Slight swelling - Slight swelling, small ridge along one or more joints, very little if any panel surface lift
- 3 = Moderate - Noticeable edge swelling and some panel surface lift extending away from joint
- 4 = Objectional - Severely raise edge and swelling extending noticeably under the panel surface
- 5 = Failed test - Water leaked out of the ring, leaving no continuous film of water inside the ring  
(this grade is given even if there is no swell of the edge joint)
